# Safe use of bed rails

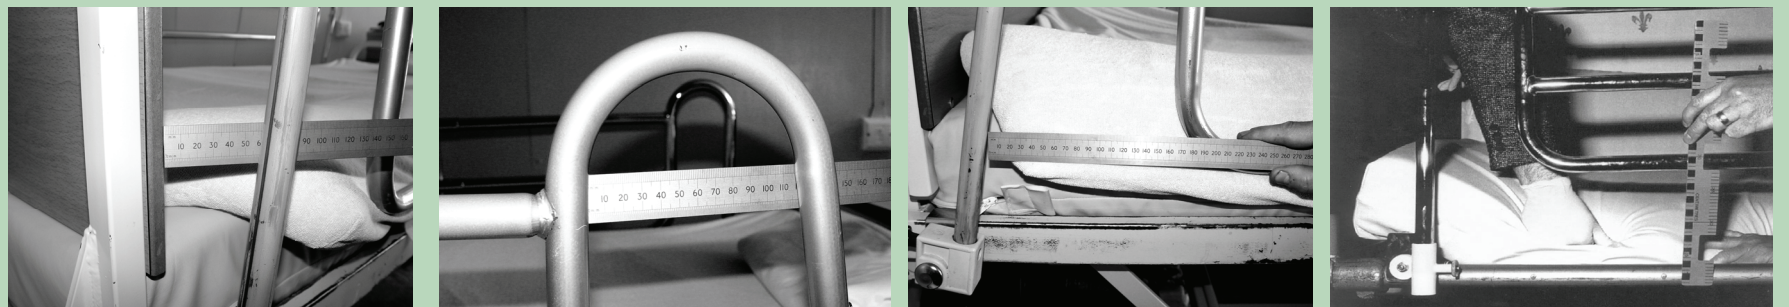
'Third party' bed rails, as photographed below, are not model specific and fit a wide range of beds. The principles set out below apply to all types of bed rails.

Bed rails should be fitted so that the gap between their end and the headboard is less than 60mm.

All gaps between the rail bars for adults must be 120mm or less and for children 60mm or less.

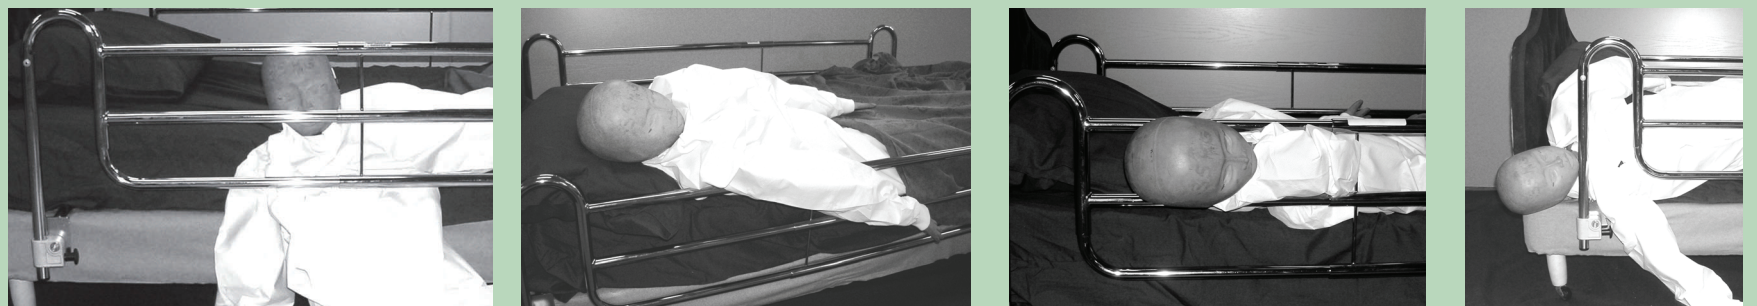
Most of the deaths caused by bed rails could have been avoided if thorough risk assessments of the bed occupant, the bed and the bed rail combination had been carried out.

MHRA investigations have also shown that many serious and fatal incidents with bed rails have been caused by a lack of maintenance.

Bed rails must be inspected on a regular basis to ensure they are in good condition.
